SRM/sm/1238452
05th September 2024

PENNALTA COLLIERY, PENALLTA
STRUCTURAL STABILITY OF POWEHALL BUILDING

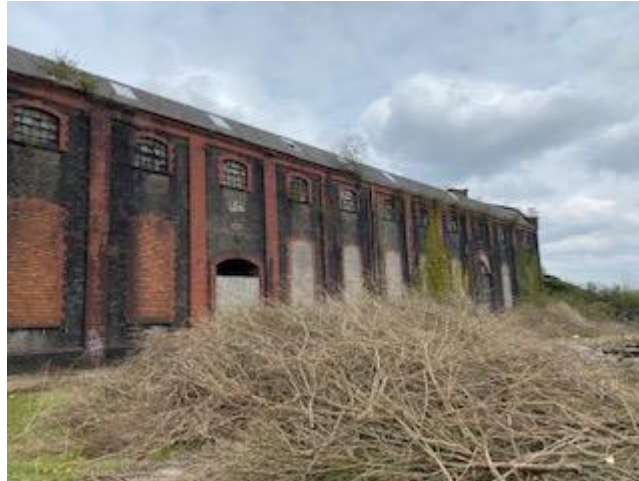
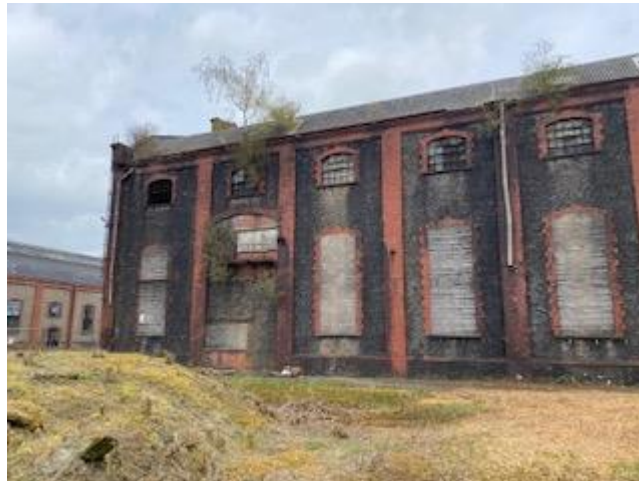
- 1.) The Powerhall is of solid masonry with structural openings at high level. The building is believed to have been completed around 1906. The structural openings at ground floor level in the external elevation have been filled in with brickwork/blockwork. The walls have full height brickwork piers between the structural openings which are visible externally.
- 2.) The property has a corrugated roof over supported on original lightweight steel trusses.
- 3.) Internally, the original arches over the structural openings can be seen. Based on the depth of the reveals to the window openings, the walls appear to be at least 500mm thick overall and of solid construction.

Figure 1
External elevation to Powerhall.

Figure 2
As Figure 1

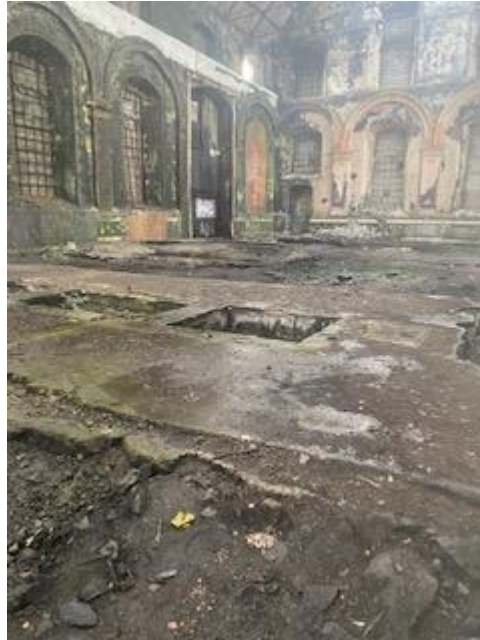
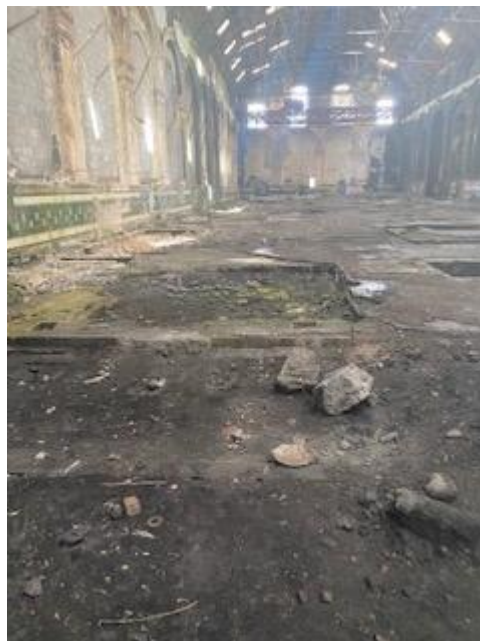
- 5.) Internally, there is evidence of water ingress. This is due to the condition of the roof. There is no evidence of any major structural deterioration of the building as a result of the water ingress.

Figure 3
Internal elevation (1 of 2)

Figure 4
Internal elevation (2 of 2)

10) The proposal is to construct an internal timber frame within the building. All vegetation growth to the internal elevations of the perimeter walls will require treatment to remove the vegetation and prevent further growth. This also applies to the external vegetation.

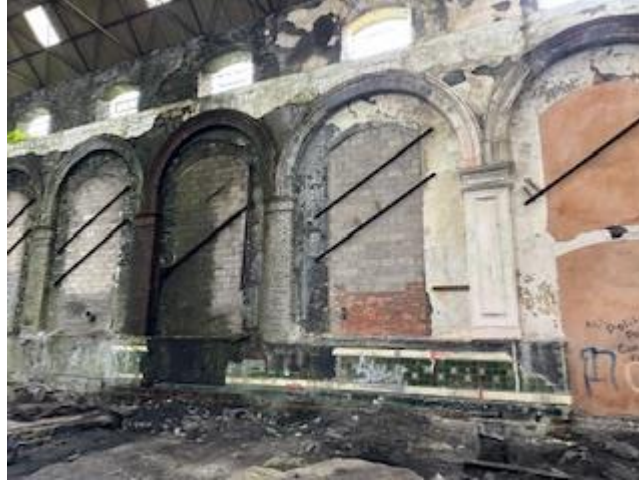
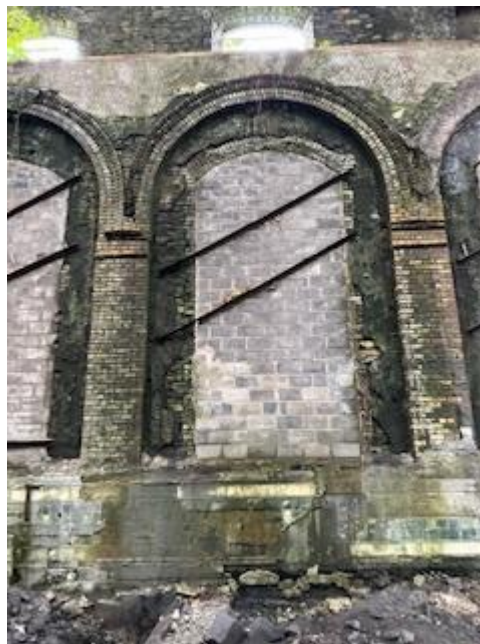
- 8.) Internally, the blockwork infill to the windows is restrained with steel bars to ensure that the blockwork does not fall into the building. These restraints should be checked annually.

Figure 5
Window infill restraints

Figure 6
As Figure 5

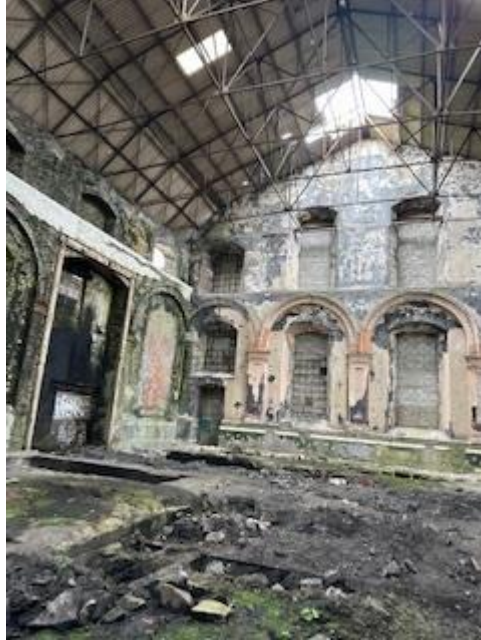
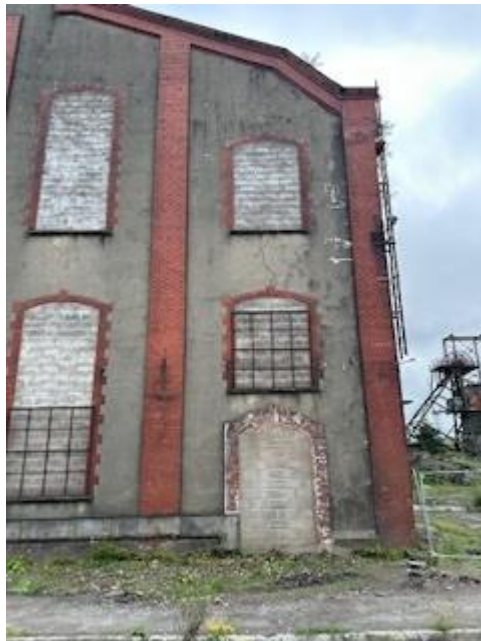
- 7.) There is some minor cracking to the left-hand gable end adjacent to the roadway. The cracking occurs between the first and second floor windows. The crack appears to have penetrated the full depth of the wall and is also visible internally. The crack will require a structural repair. The repair is likely to comprise a 'Helifix' type repair which involved stitching the crack with stainless steel bars. These repairs would be concealed and would not be obvious on the elevation.

Figure 7
Internal vertical crack to gable end window
corresponding to Figure 8

Figure 8
External crack to gable end window.
