COAL MINING RISK ASSESSMENT

PROPOSED RESIDENTIAL DEVELOPMENT

THE FORMER PENALLTA COLLIERY

26/08/2025

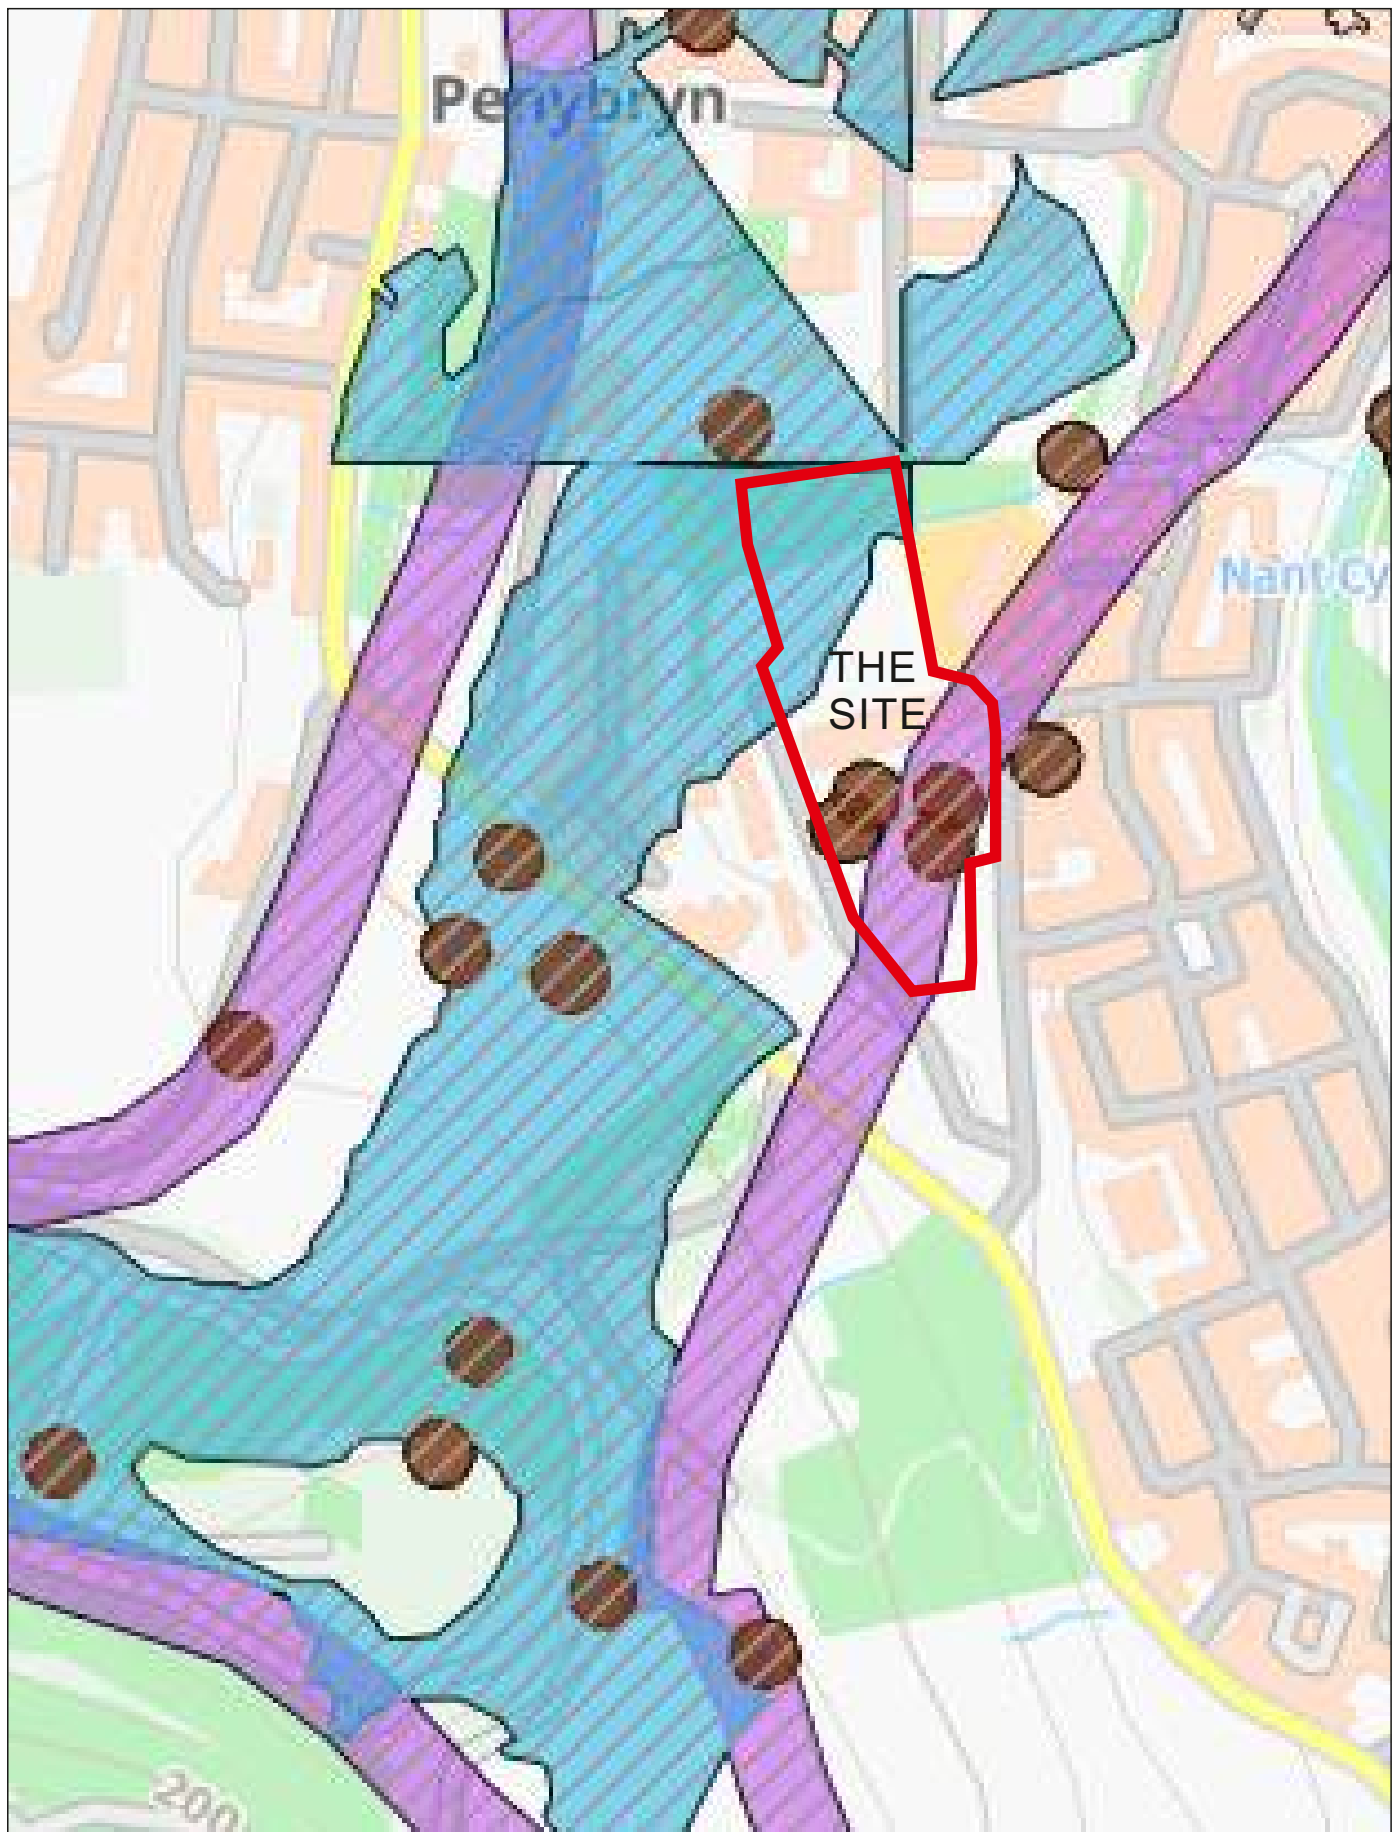
FIGURE 4

2b) The C.A. interactive viewer contains a vast amount of information from various sources, particularly on the mining data window. An extract from the Planning Window can be seen in Figure 4. The hatched areas are classed as Development High Risk. The purple linear area signifies a 20m buffer zones around a coal seam outcrop. This is clearly the Mynyddislwyn outcrop in Figure 3. The brown circles are mine entry potential zones of influence, matching the positions in Figure 3. A significant proportion of the northwest of the site is a blue area of Development High Risk. The colour signifies recorded shallow workings.

COAL AUTHORITY INTERACTIVE VIEWER, PLANNING WINDOW.
HATCHED AREAS ARE DEVELOPMENT HIGH RISK.

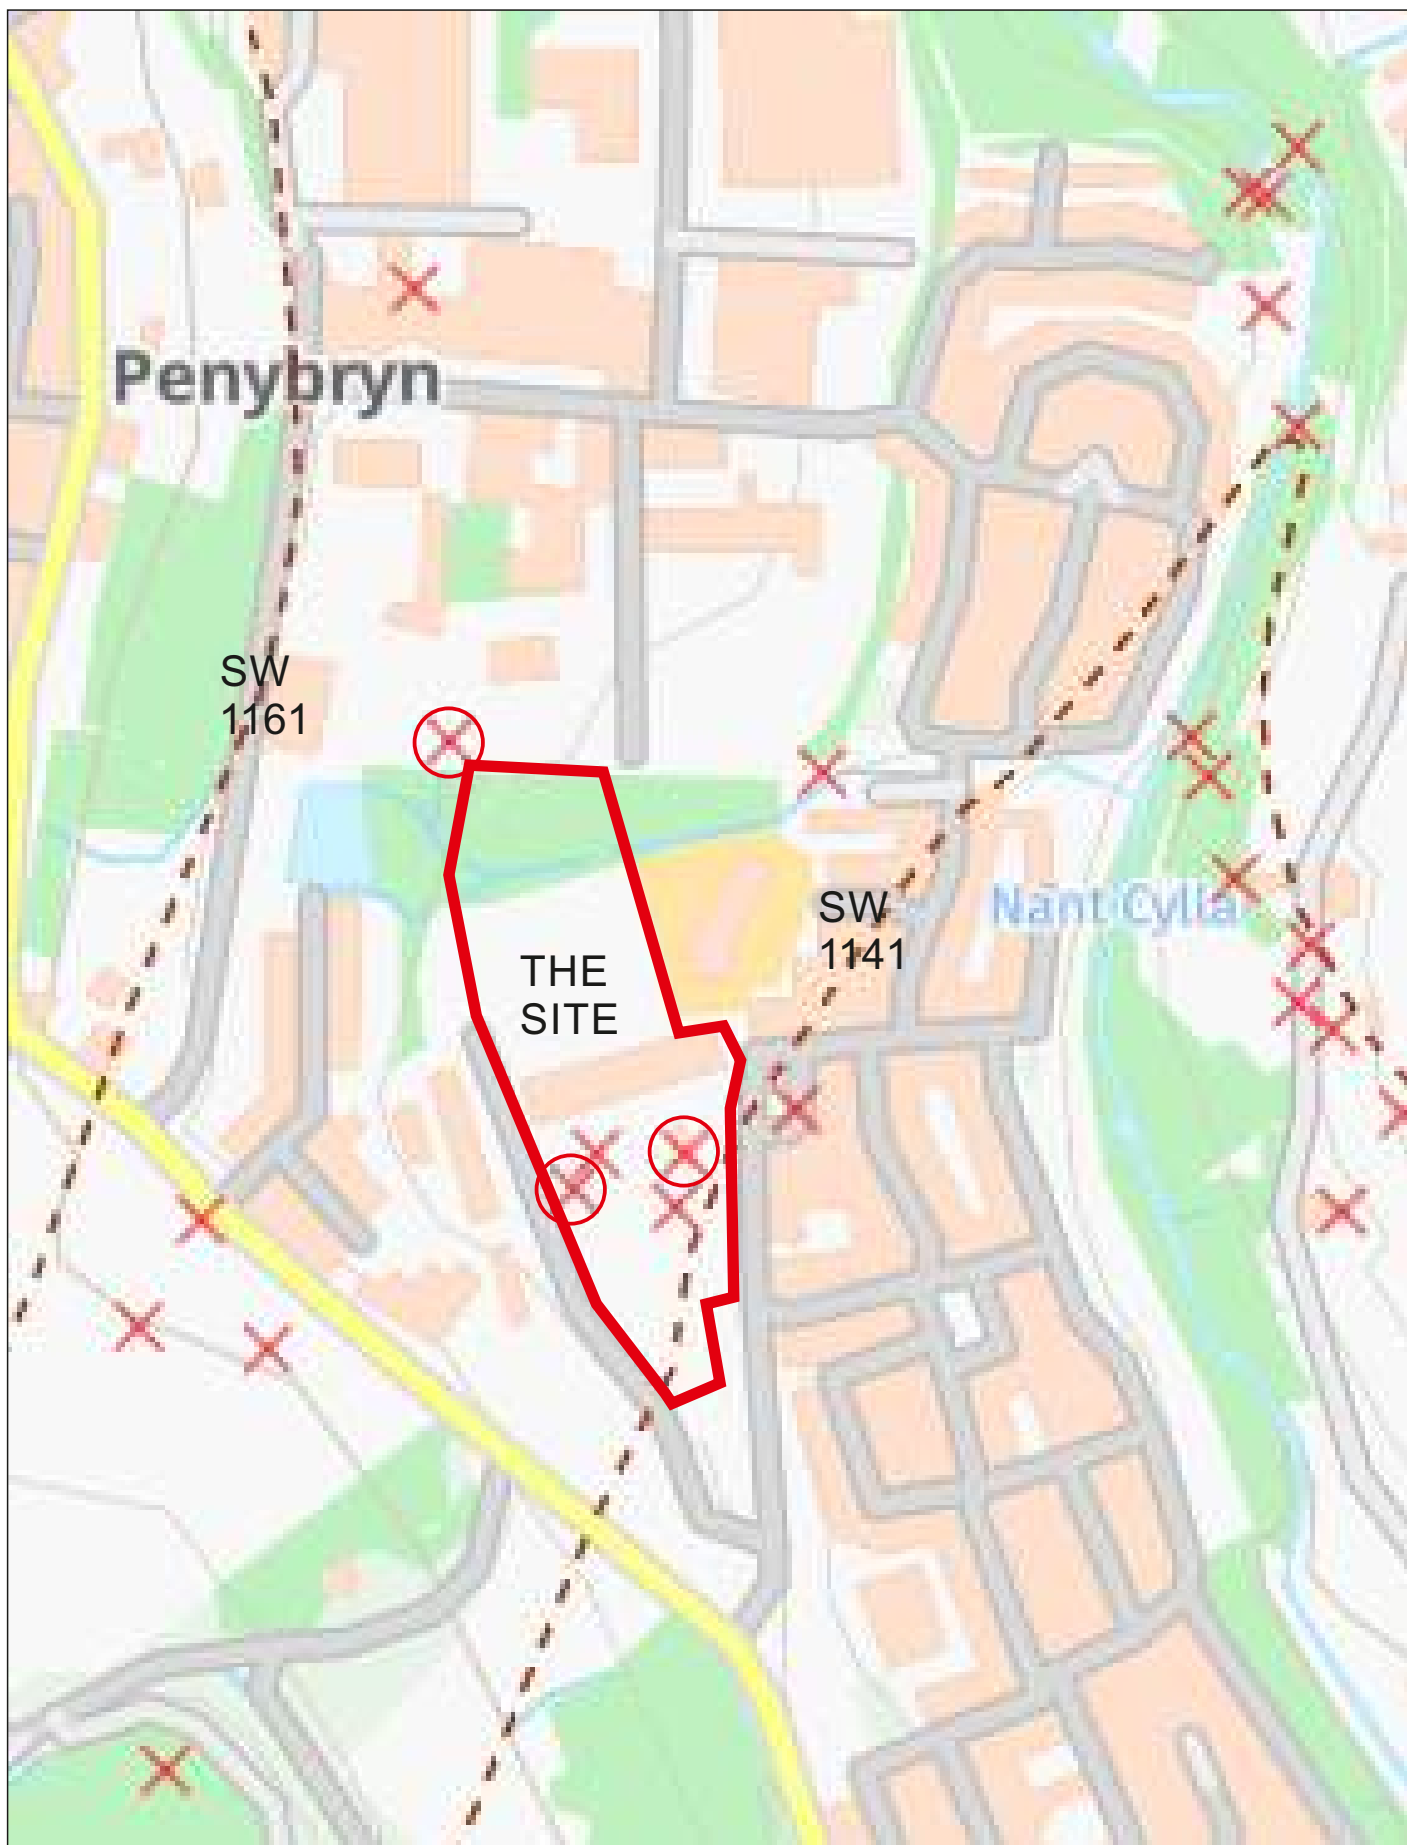
The red crosses are mine entries. The Mining Data Window database often contains data inexplicably not contained in the Consultants Report. The shafts have been circled in Figure 5. Just off the northwest corner of the site 313196-002 is an air shaft 29.3m deep and capped in 1973. In the southern part of the site the two circled shafts are 313195-001 (west) and 314195-001 (east). These are the downcast and upcast shafts of Penallta Colliery. At 743m and 687m respectively they were amongst the deepest shafts ever sunk in South Wales. The remaining three mine entries are “old levels” (sub horizontal coal mines) with similar orientations of 236°, 265° and 270° i.e. westward into the crop of the Mynyddislwyn.

FIGURE 5
C.A. VIEWER, MINING DATA WINDOW. RED CROSSES ARE
MINE ENTRIES, BROWN LINES ARE COAL SEAM OUTCROPS.

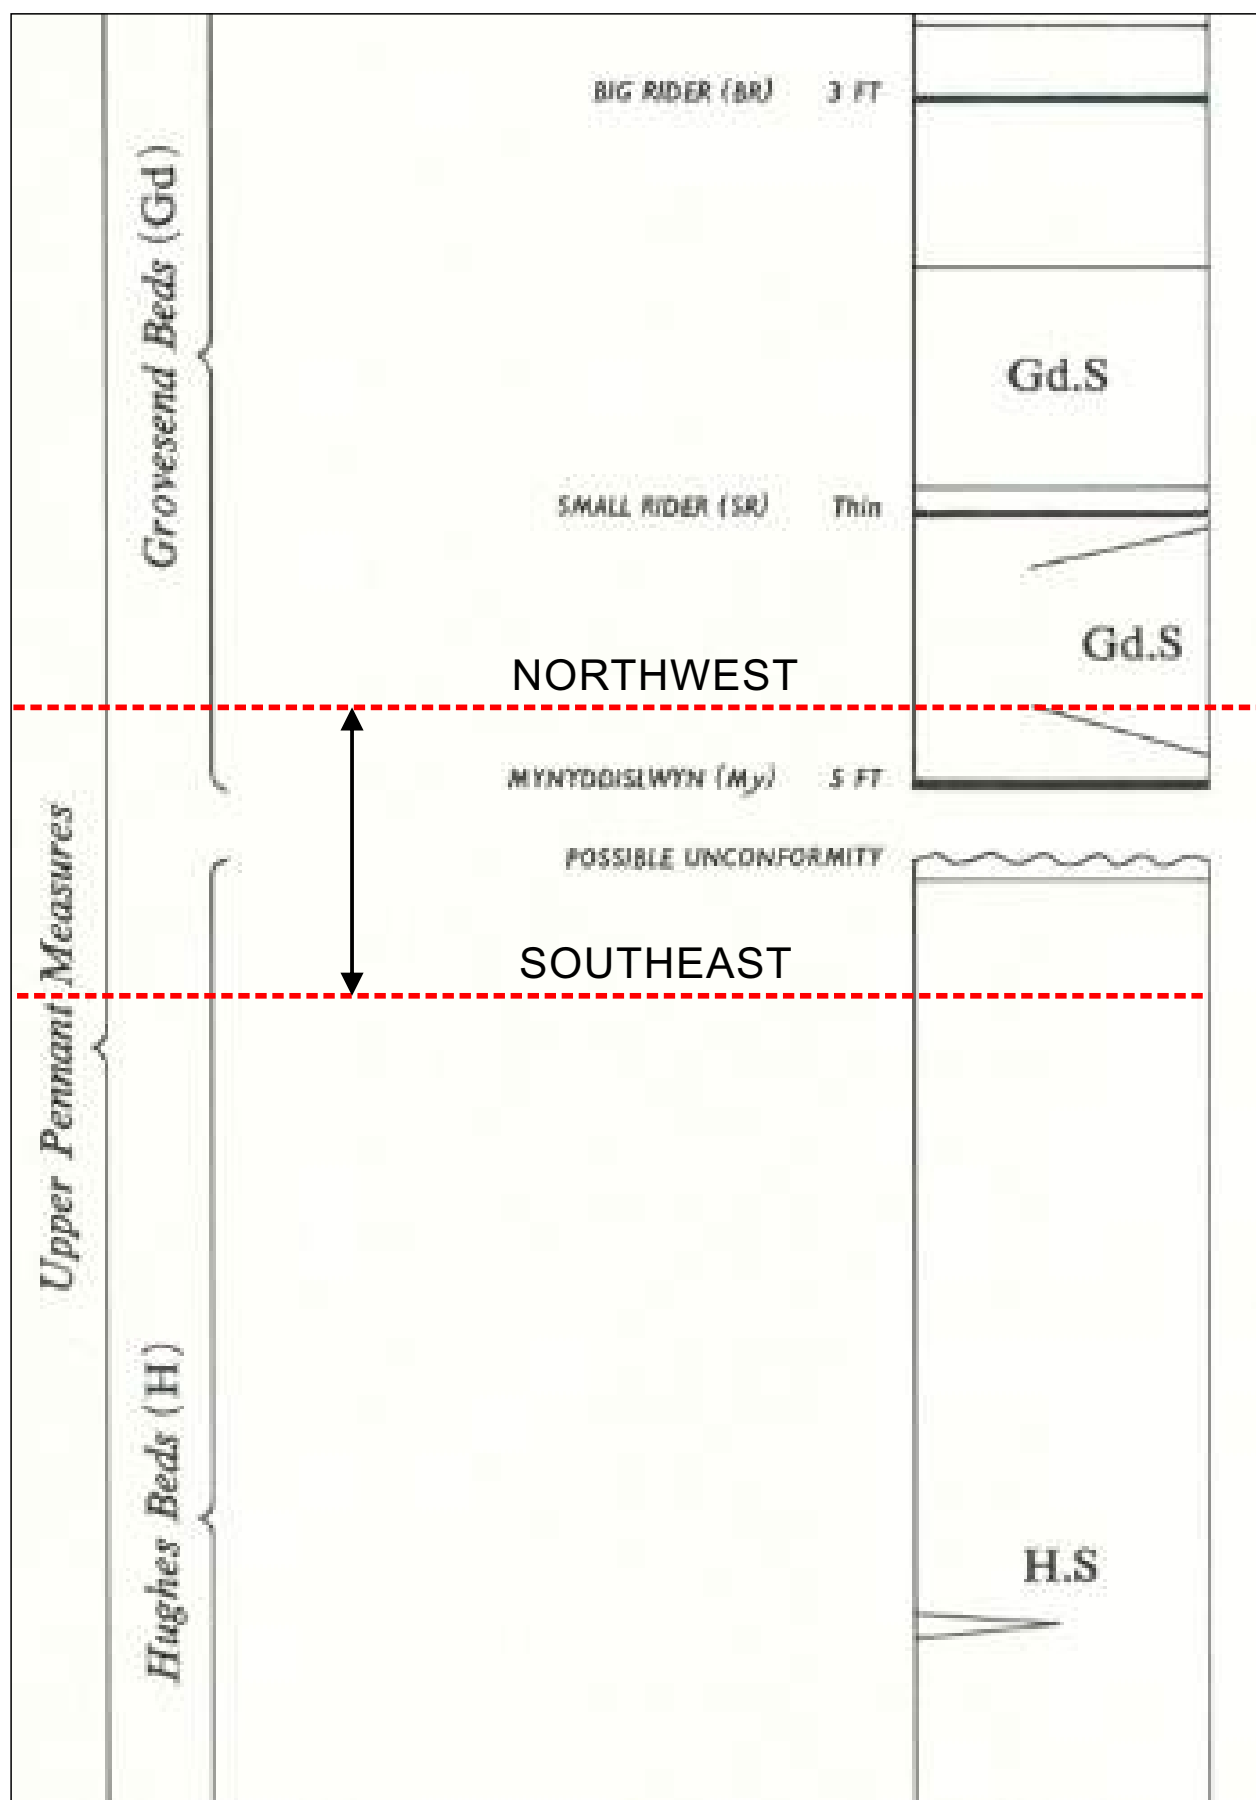
FIGURE 7
SECTION OF THE STRATIGRAPHIC COLUMN FROM ST 19NW.
THE APPROXIMATE RANGE OF SITE LEVELS IS MARKED.

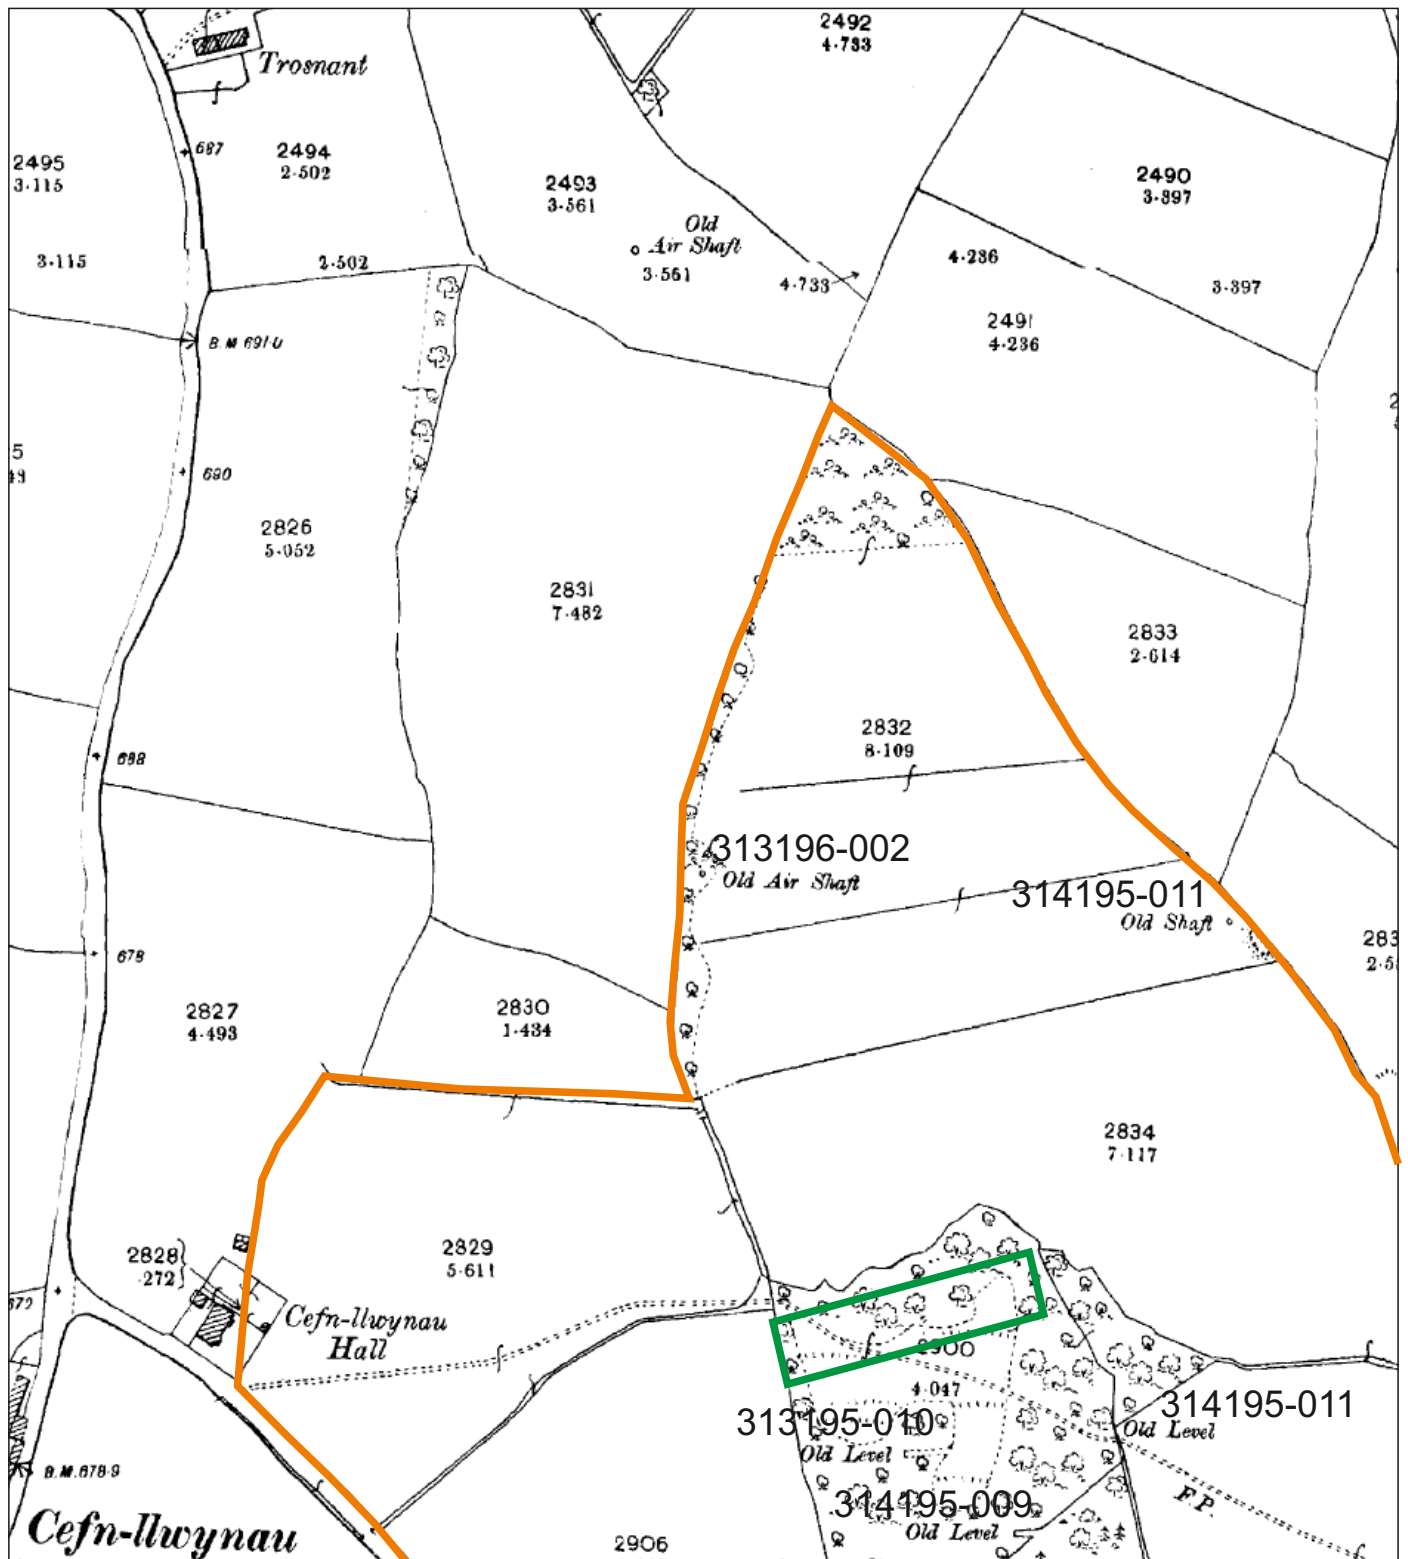
FIGURE 9

THE 1899 O.S. PRE-DATES THE CONSTRUCTION OF PENALLTA COLLIERY AND RETAINS THE ORIGINAL FIELD BOUNDARIES CORRESPONDING TO THE ESTATE BOUNDARIES ON ABANDONMENT PLAN SW2568. C.A. MINE ENTRY REFERENCES HAVE BEEN ADDED. THE APPROXIMATE POSITION OF THE POWERHOUSE IS IN GREEN.

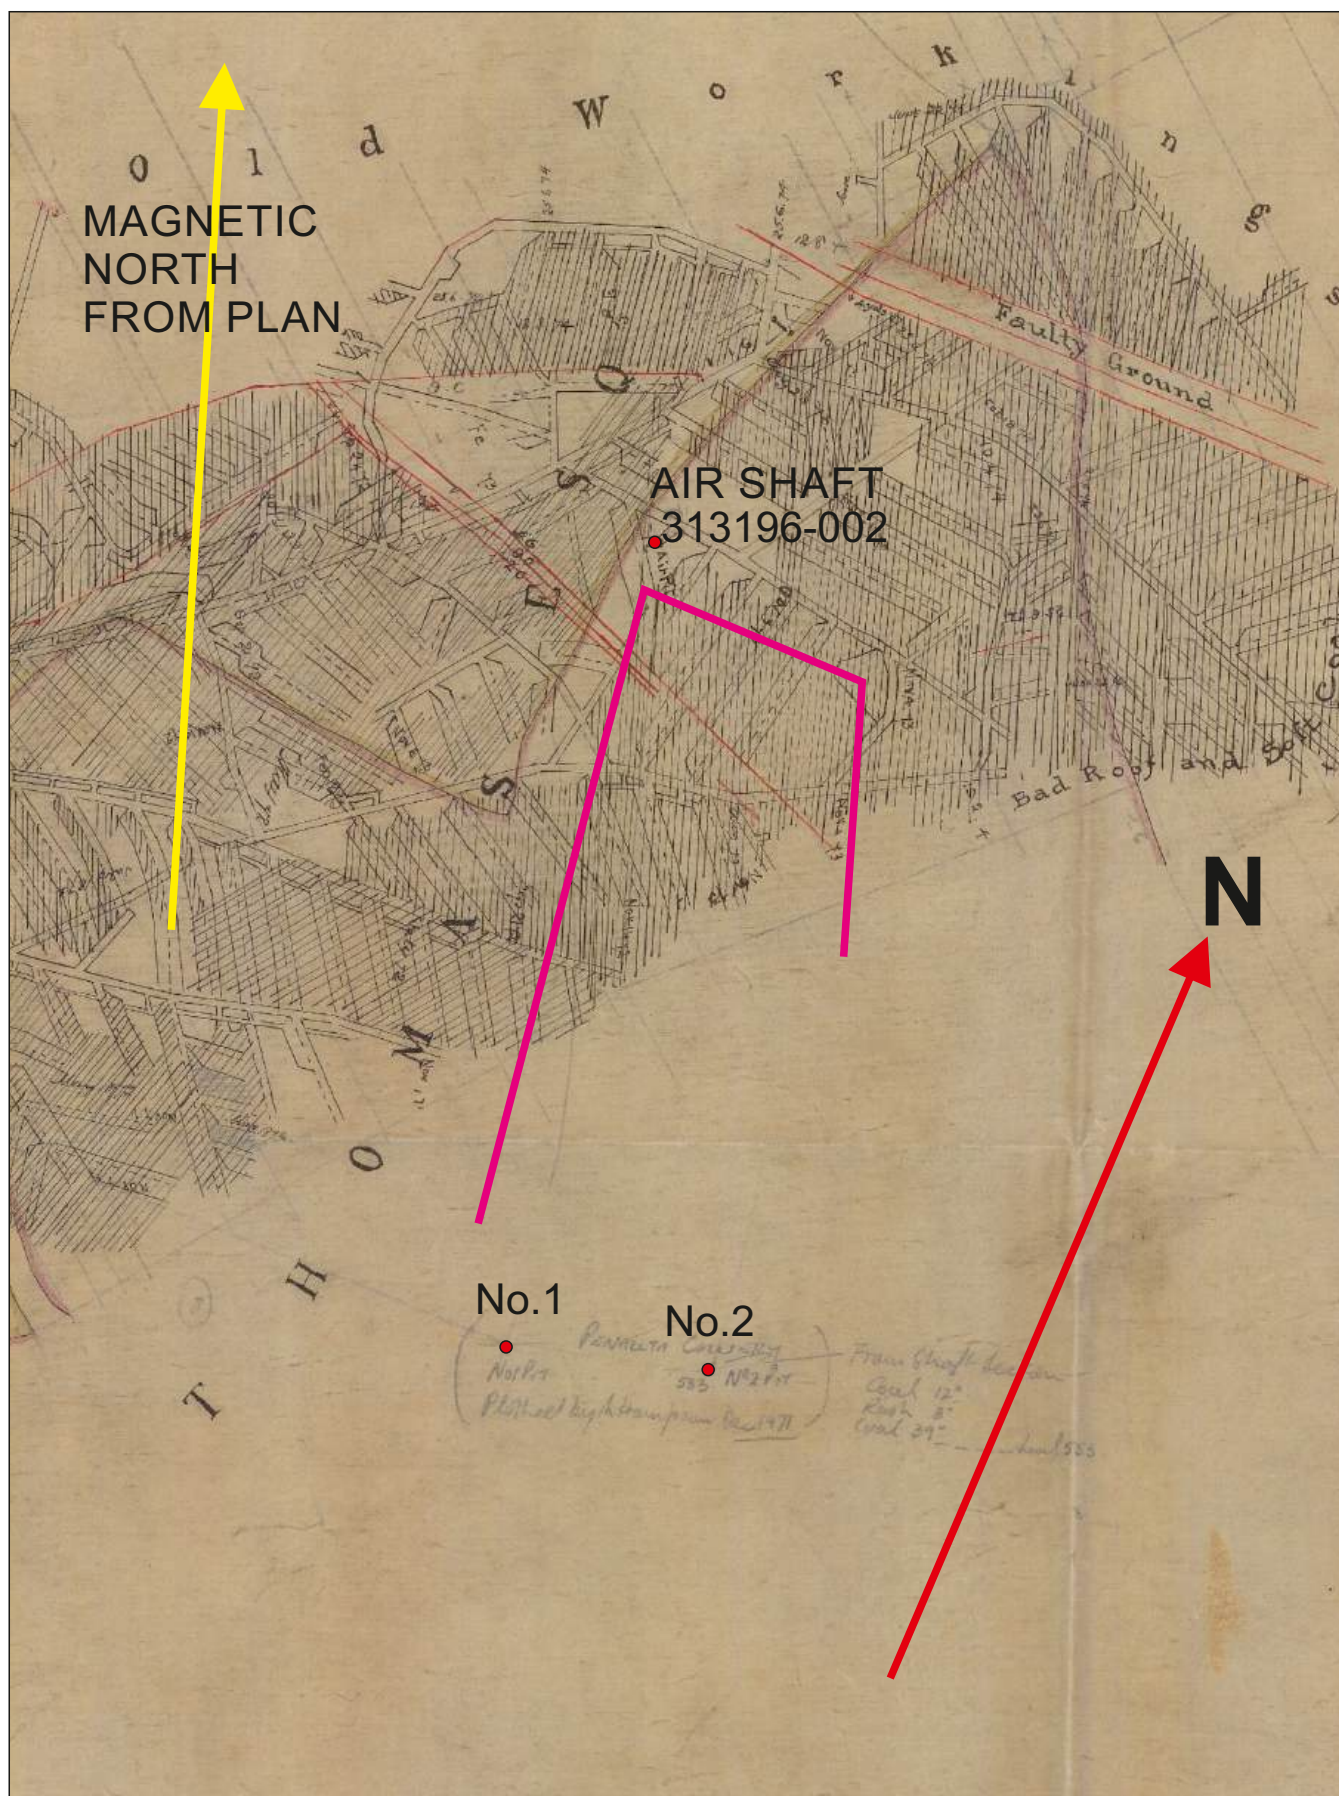
FIGURE 10
SECTION OF ABANDONMENT PLAN SWR2568. AN N.C.B. SURVEYOR HAS PLOTTED THE PENALLTA SHAFTS IN 1973. THE APPROXIMATE SITE BOUNDARY IS SHOWN ENCOMPASSING SHALLOW WORKINGS
